BRIDGE INSPECTION REPORT

Routine Inspection

BRIDGE NO.:
10C0111

STRUCTURE NAME:
MILL CREEK

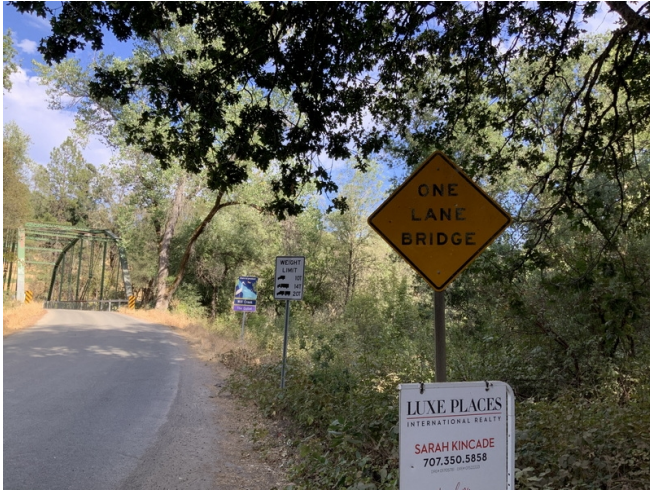
Photo 1
Operational signs at the Abutment 1 approach

There are load posting signs at both approaches that indicate the following posting:

There are "ONE LANE BRIDGE" signs at both approaches.

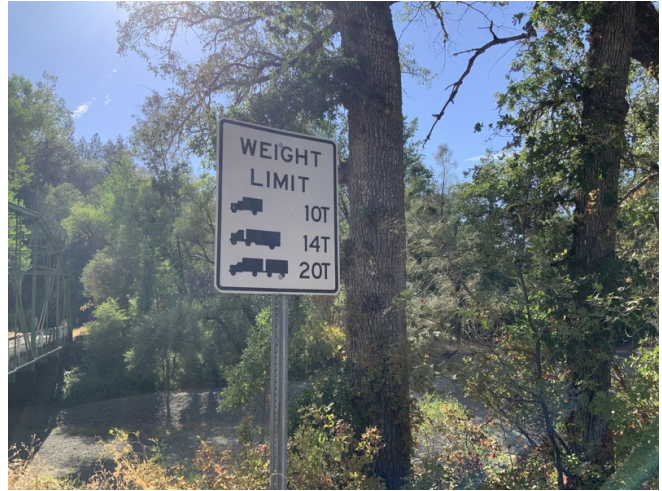
Photo 2
Load posting sign at the Abutment 2 approach

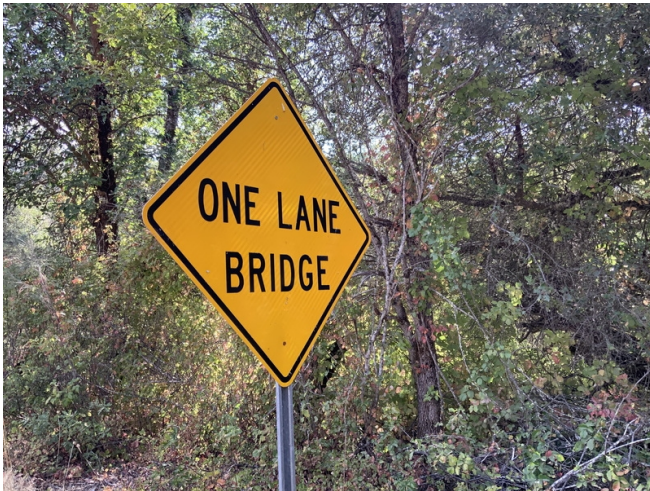
Photo 3
"One Lane Bridge" sign at the Abutment 2 approach

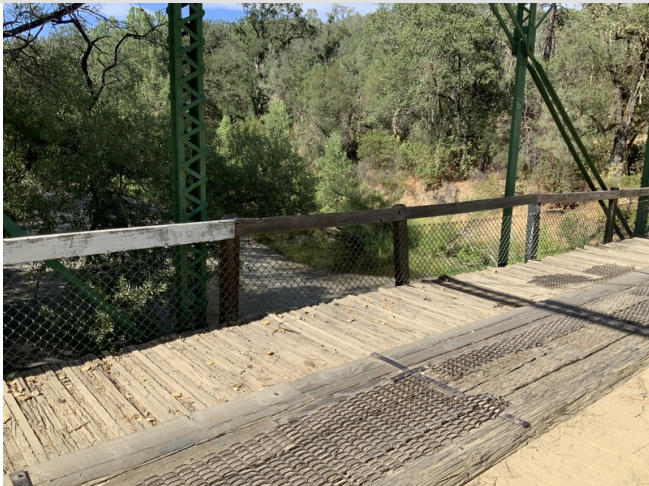
Photo 4

The previously reported missing 8 foot section of the horizontal left rail has been replaced. See Photo 4.

Replaced missing section in the left timber rail. Far right side of photo replaced

Rec Date	08/06/2013	Work By	LOCAL AGENCY	Est Cost		Dist Target
Status	PROPOSED	Action	Rail-Rehab	Str Target	ROUTINE	EA
Replace the timber bridge rail.

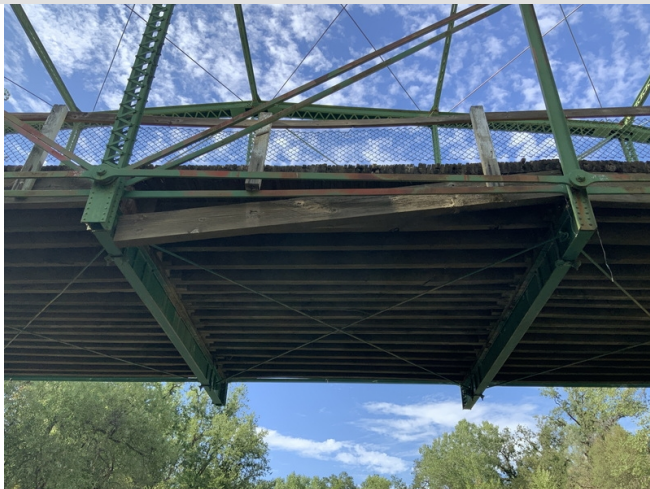
Photo 5

Stringer 17 has completely migrated off Floor beam 5 and is no longer in contact with the transverse deck timbers or the floor beam. (See Photo 5). The Mendocino County office was informed of this condition.

There is an outstanding work recommendation dated 08/17/2016 to restore these members to their original position. Most of these conditions have been previously reported and no significant changes were noted.

Stringer 17 has completely migrated off of Floor Beam 5

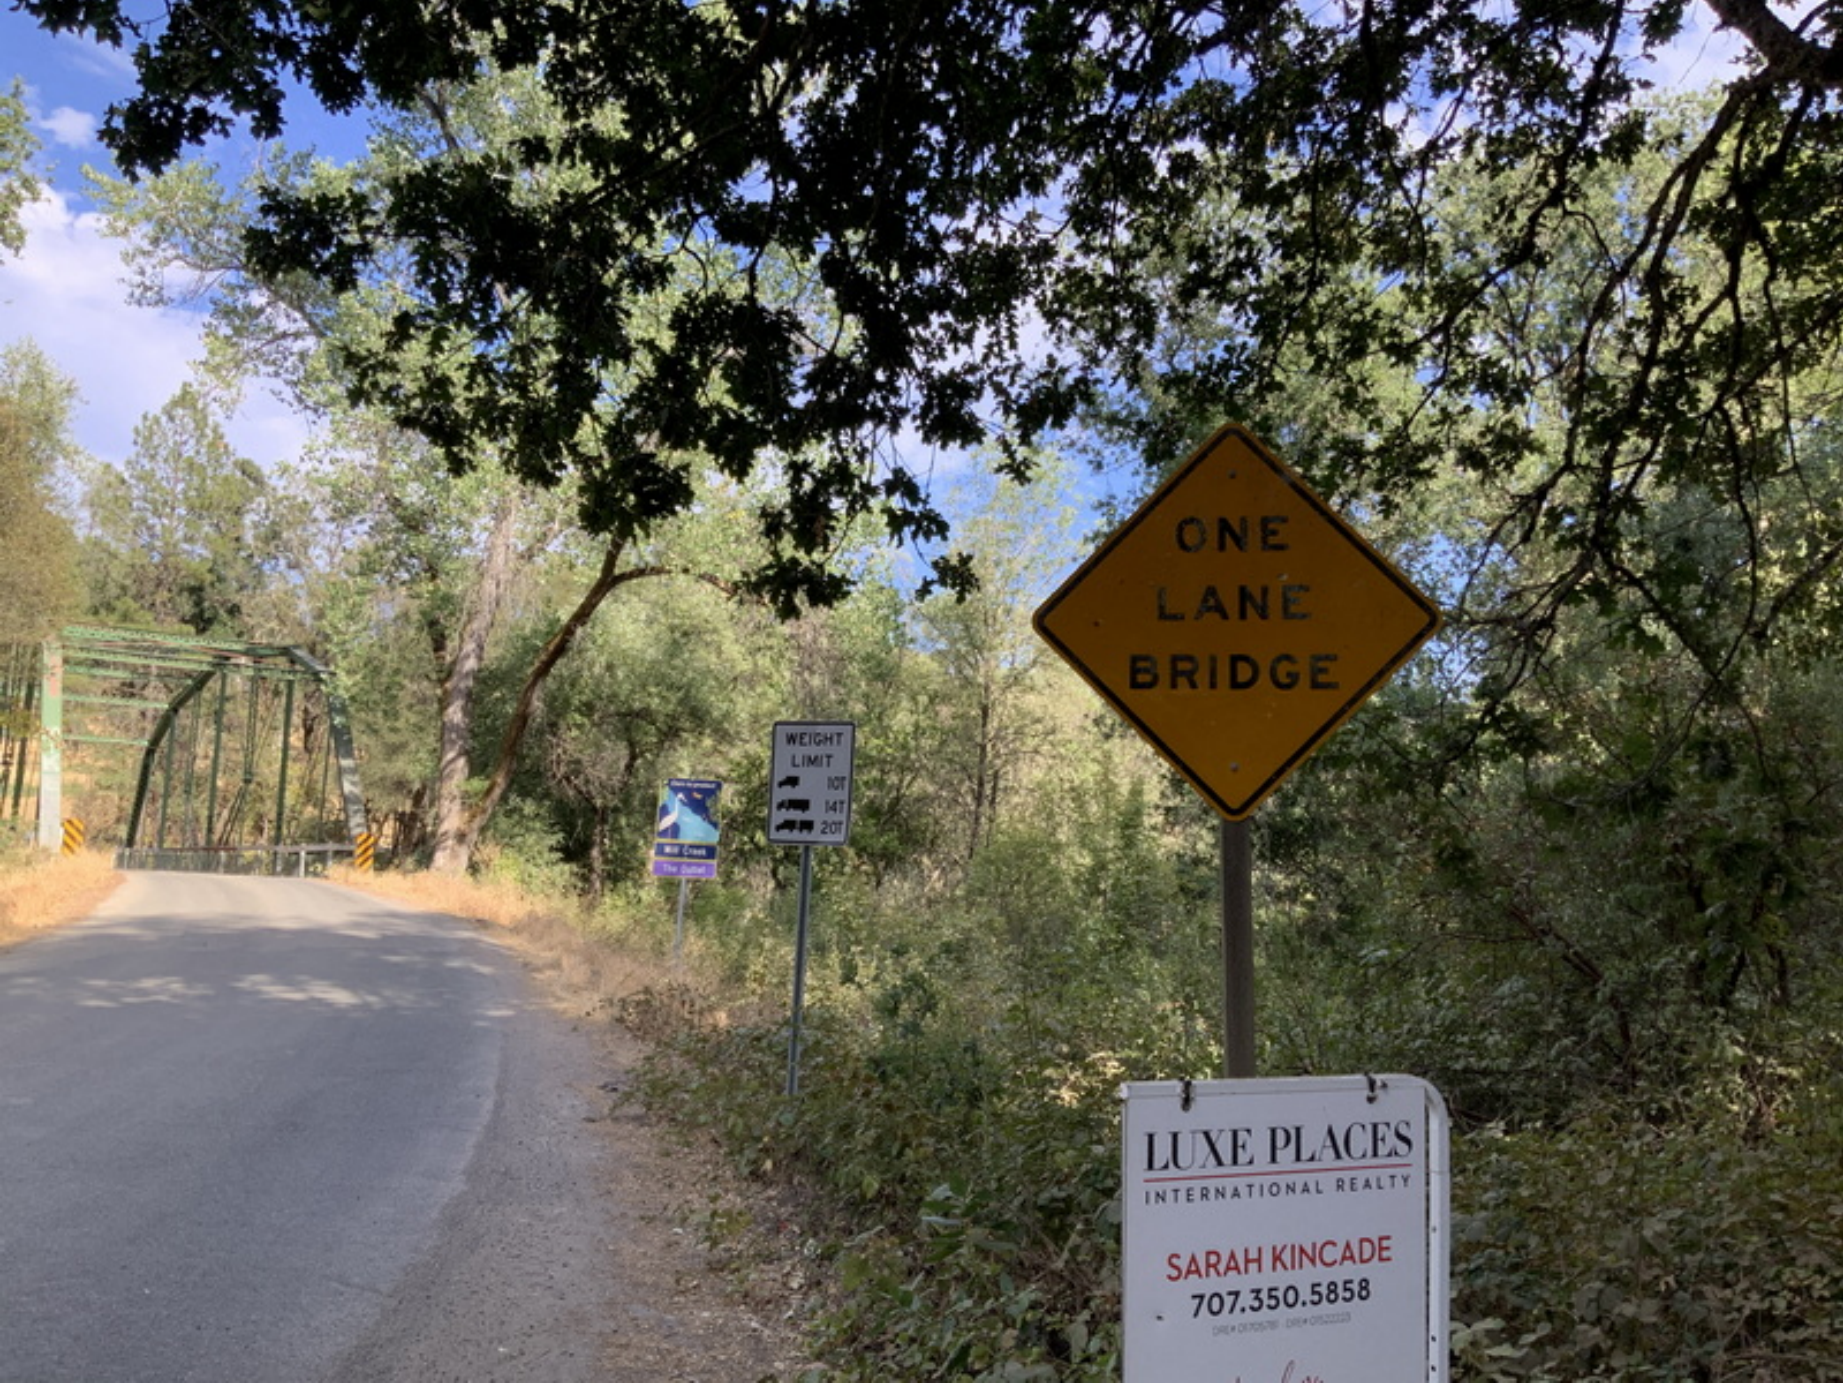
Photo #1
Operational signs at the Abutment 1 approach

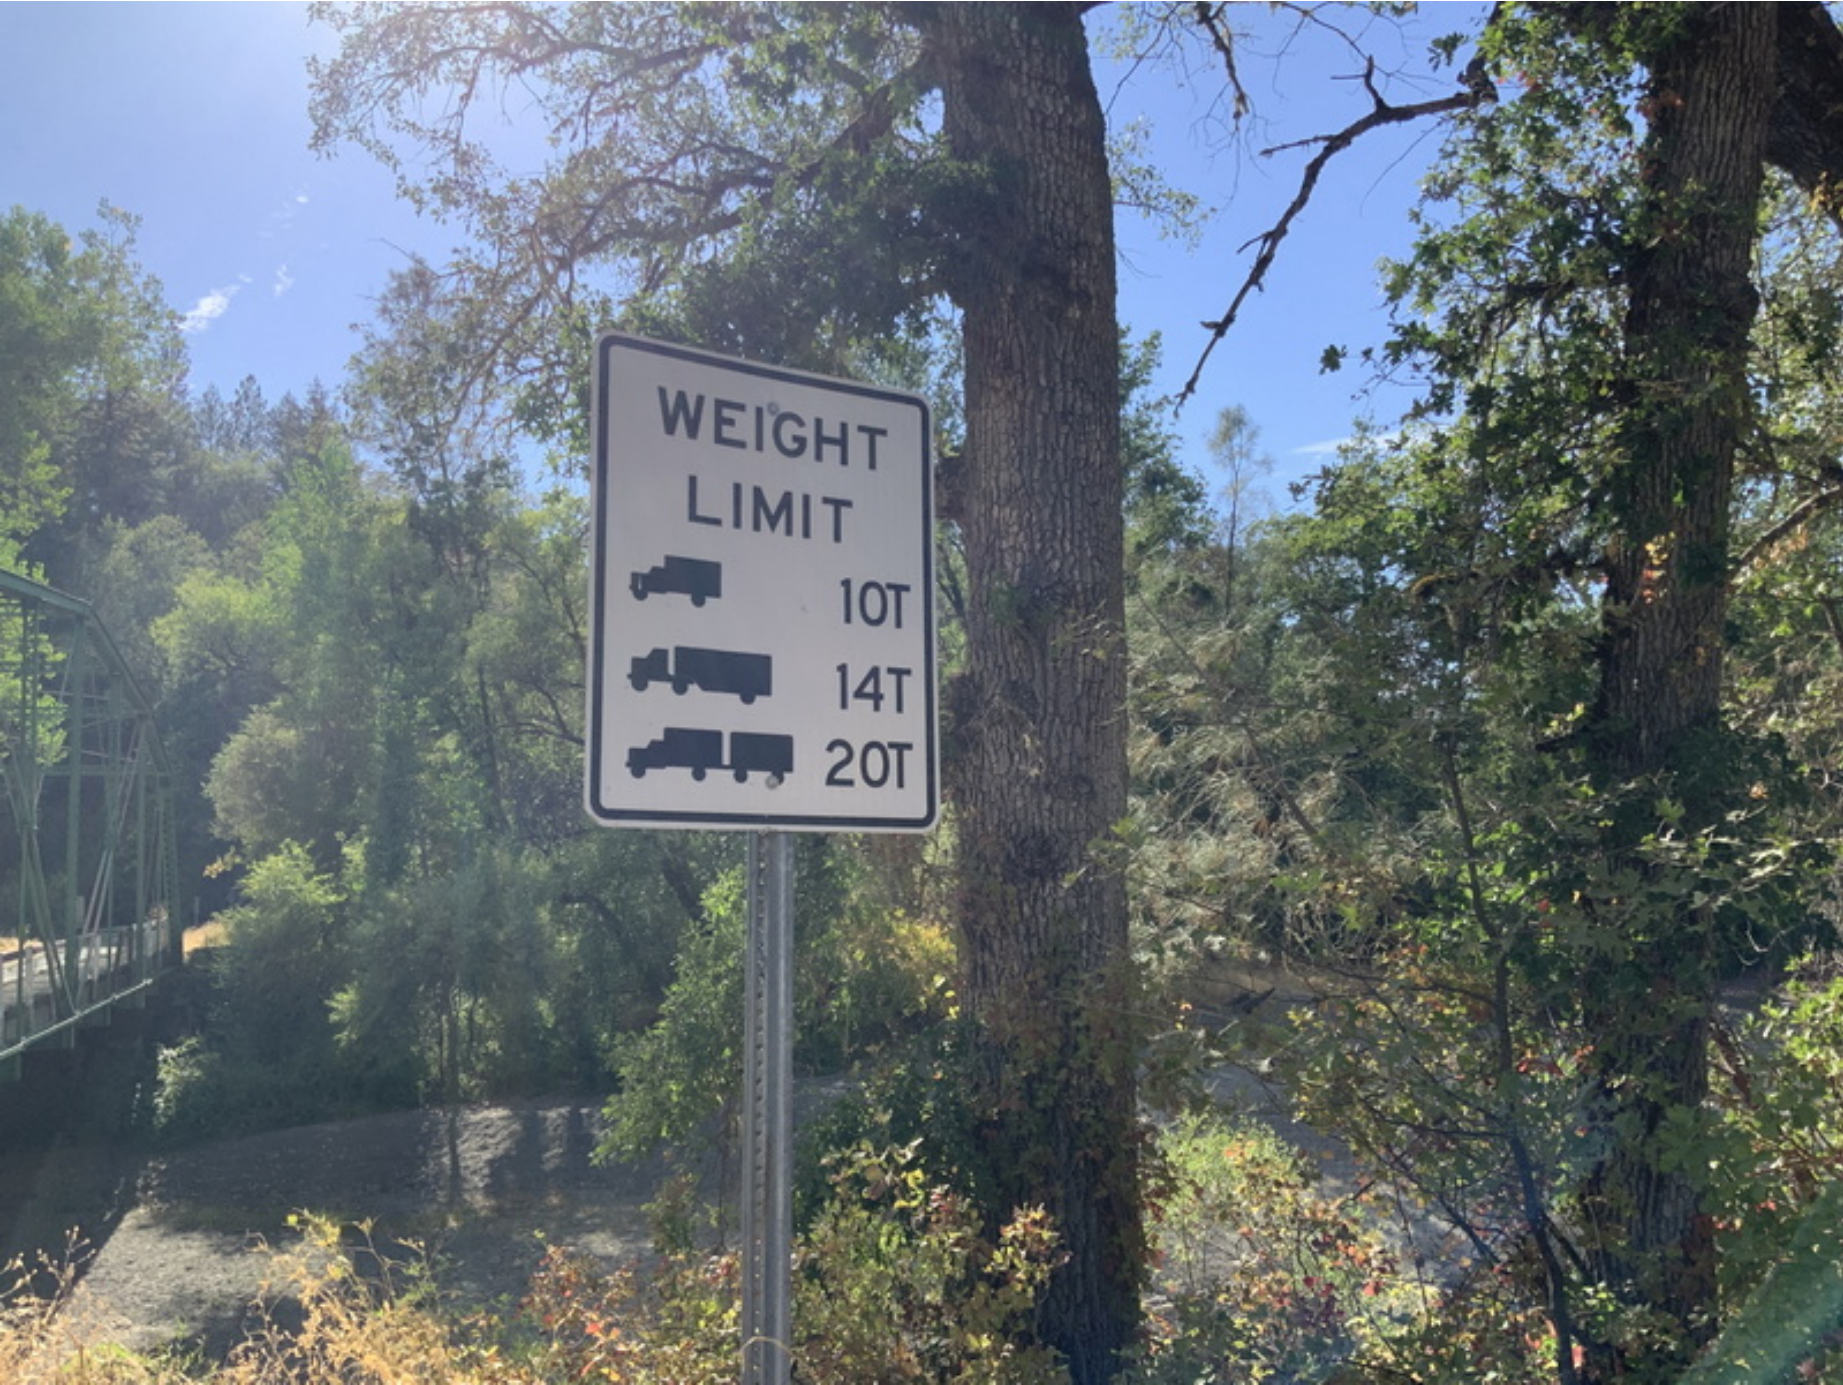
Photo #2
Load posting sign at the Abutment 2 approach

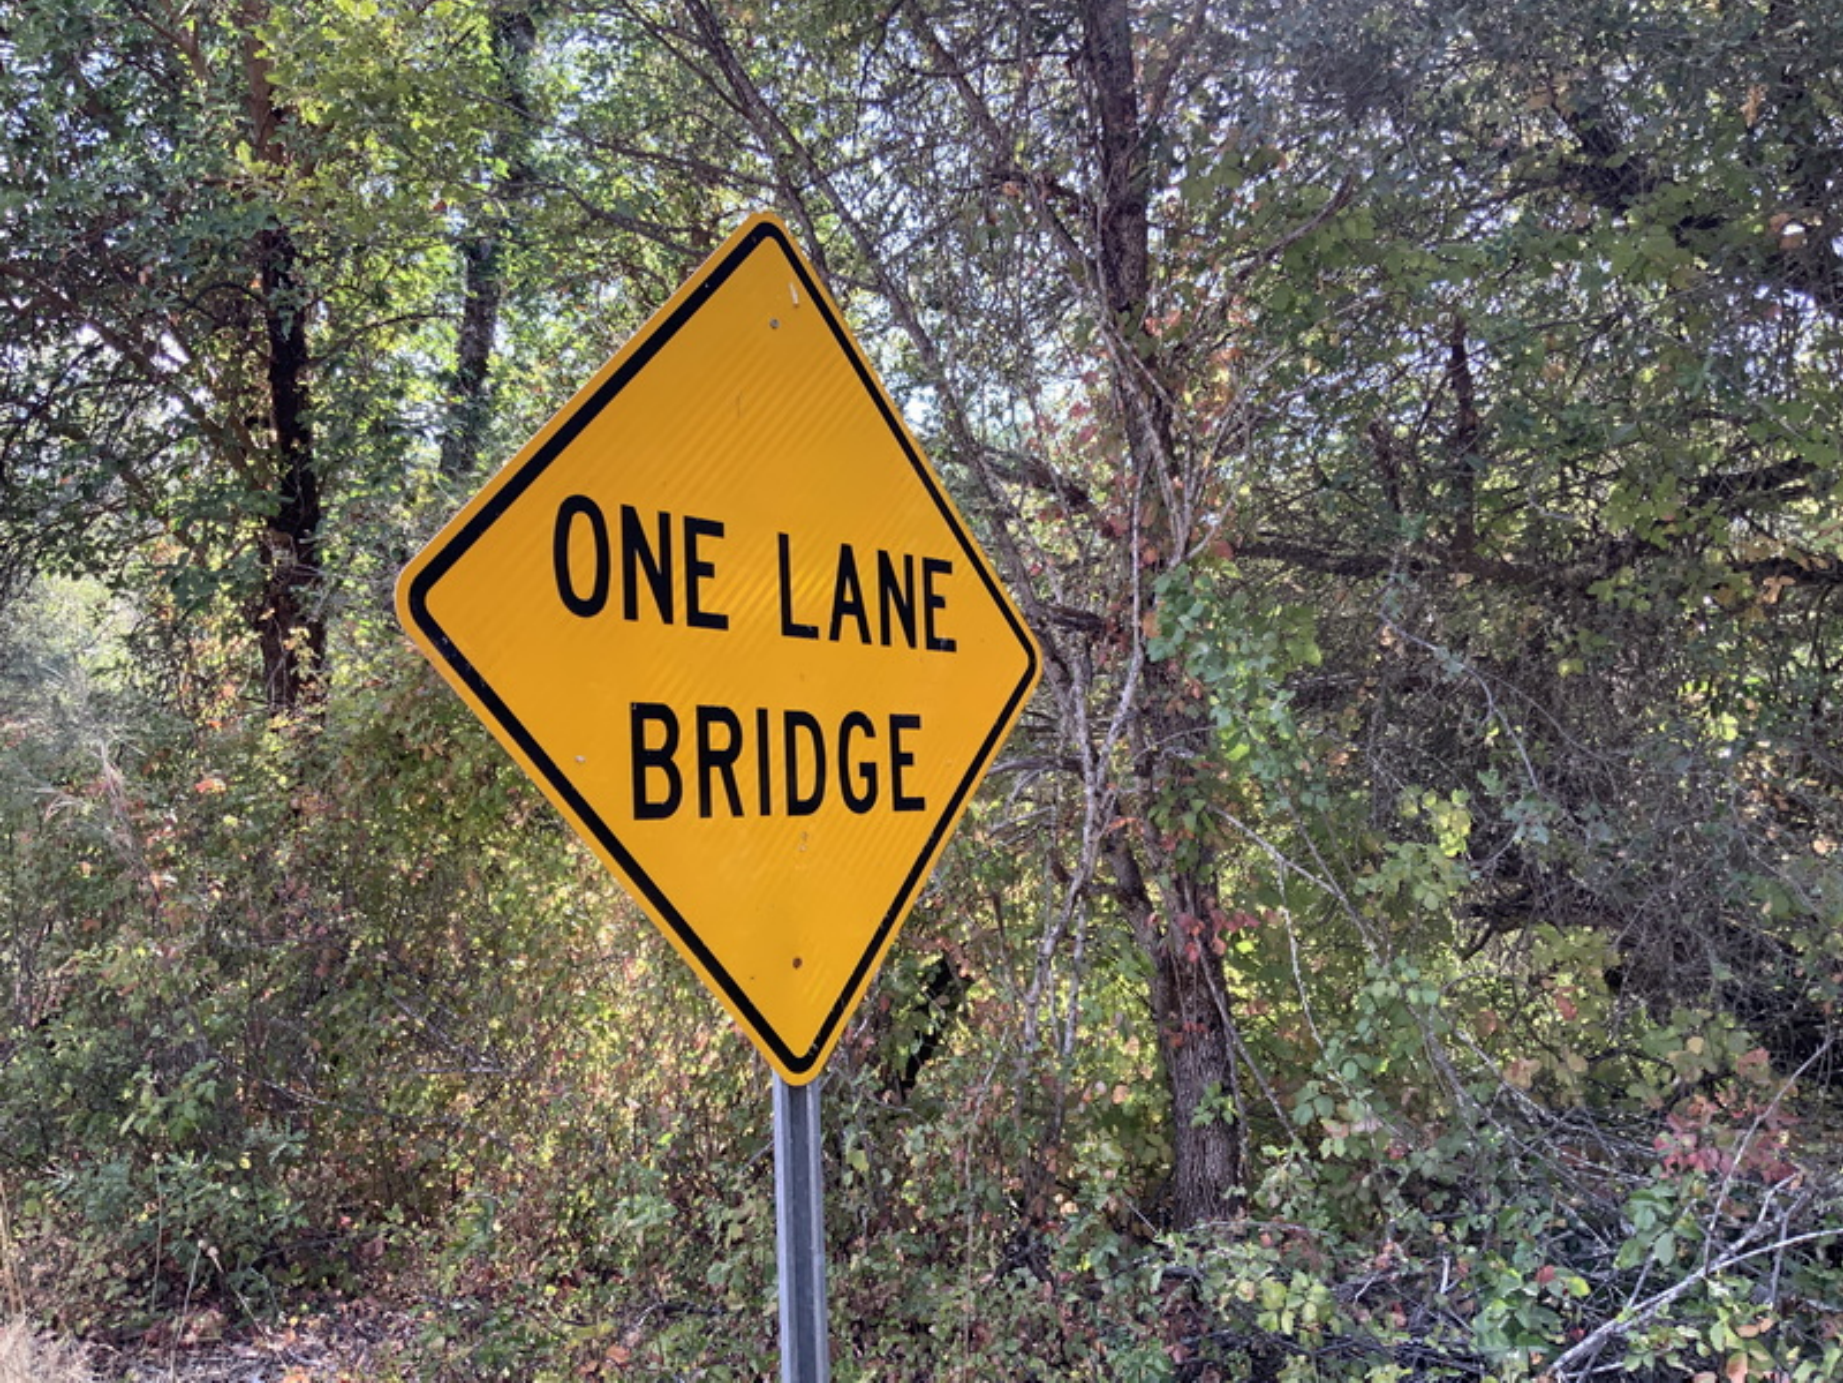
Photo #3
"One Lane Bridge" sign at the Abutment 2 approach

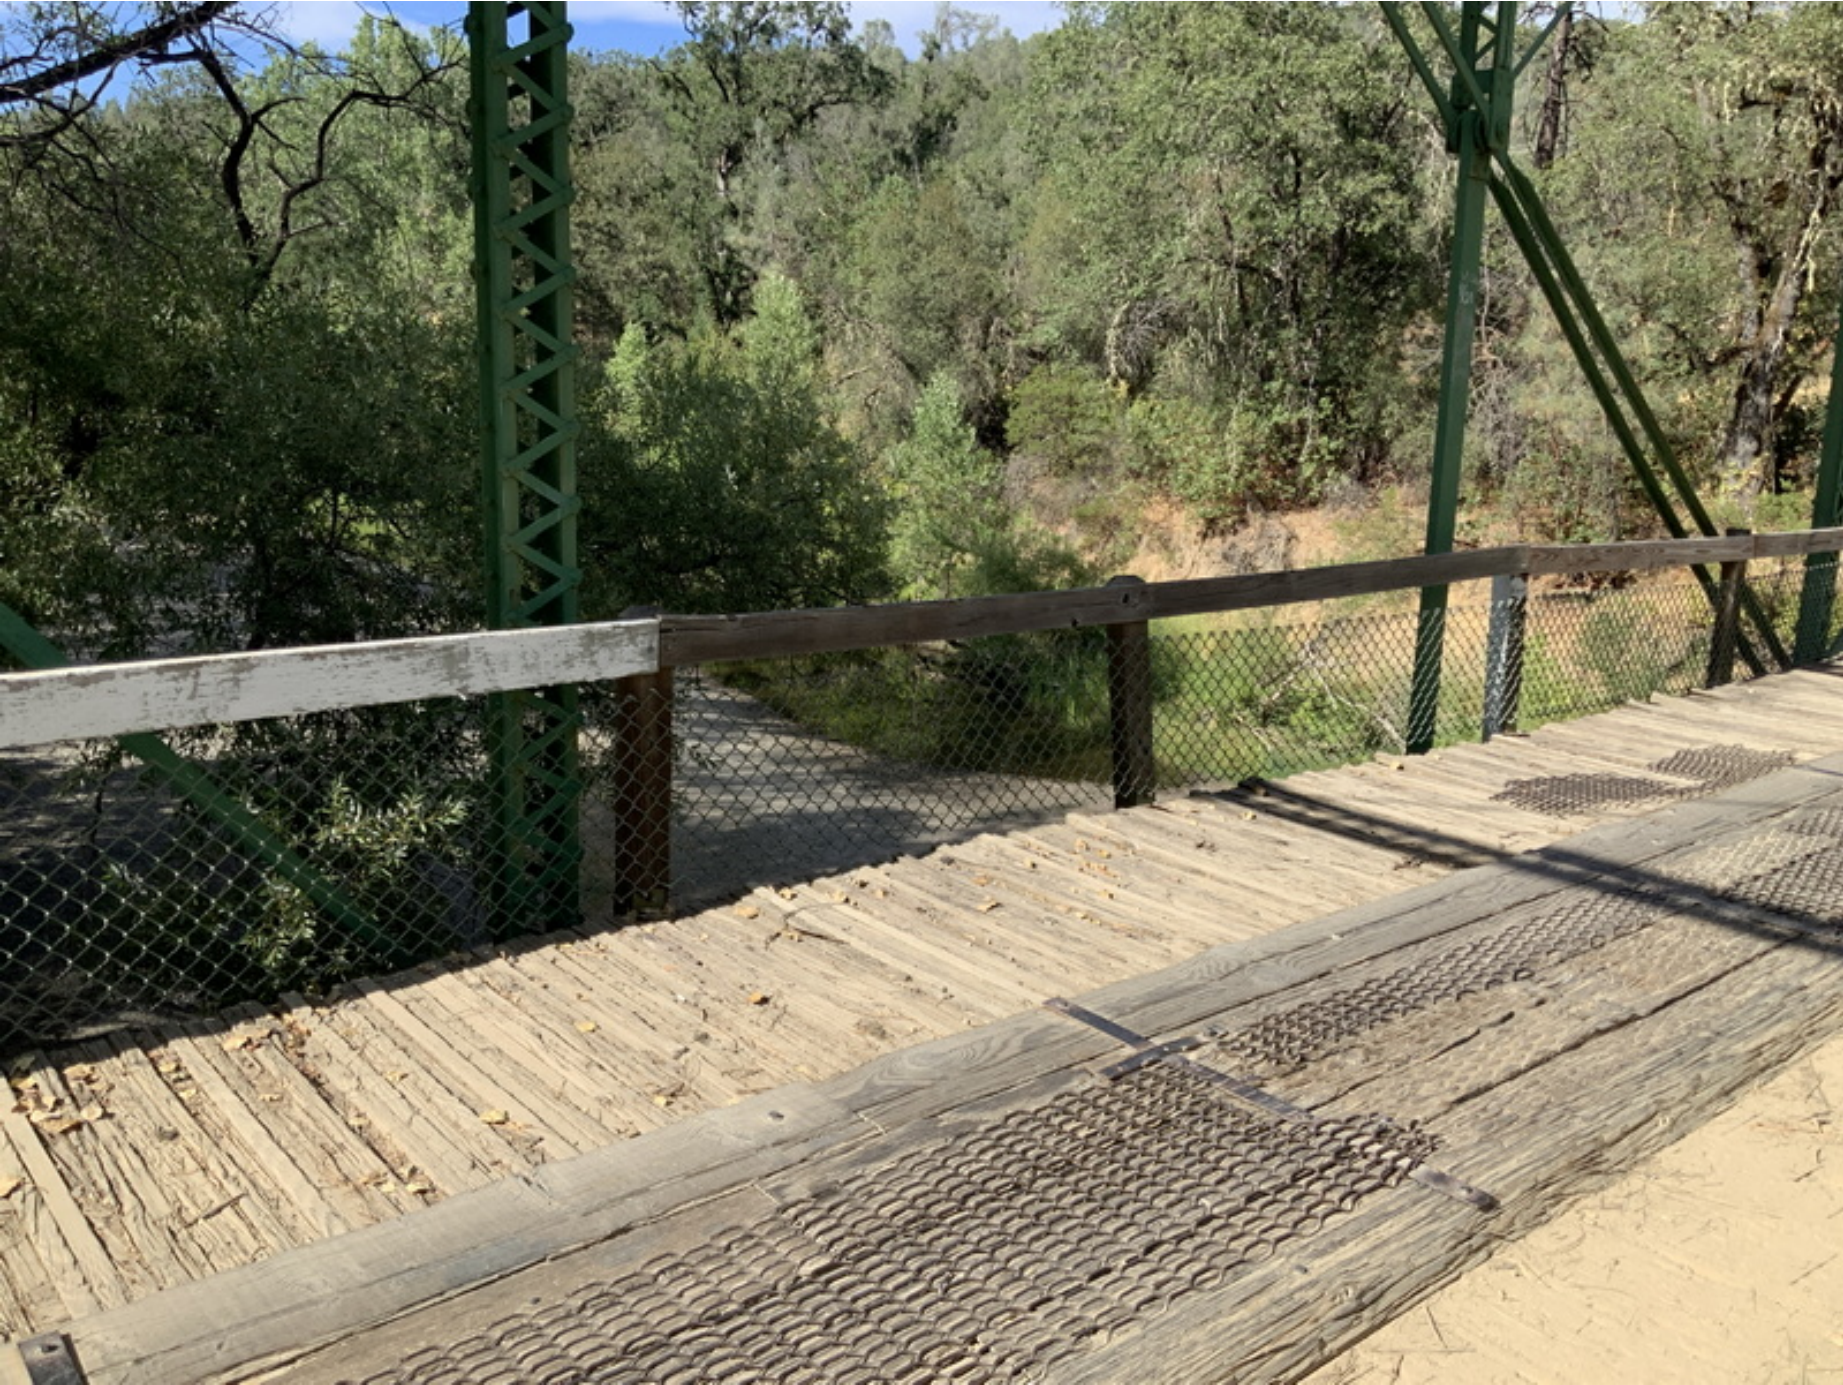
Photo #4
Replaced missing section in the left timber rail. Far right side of photo replaced

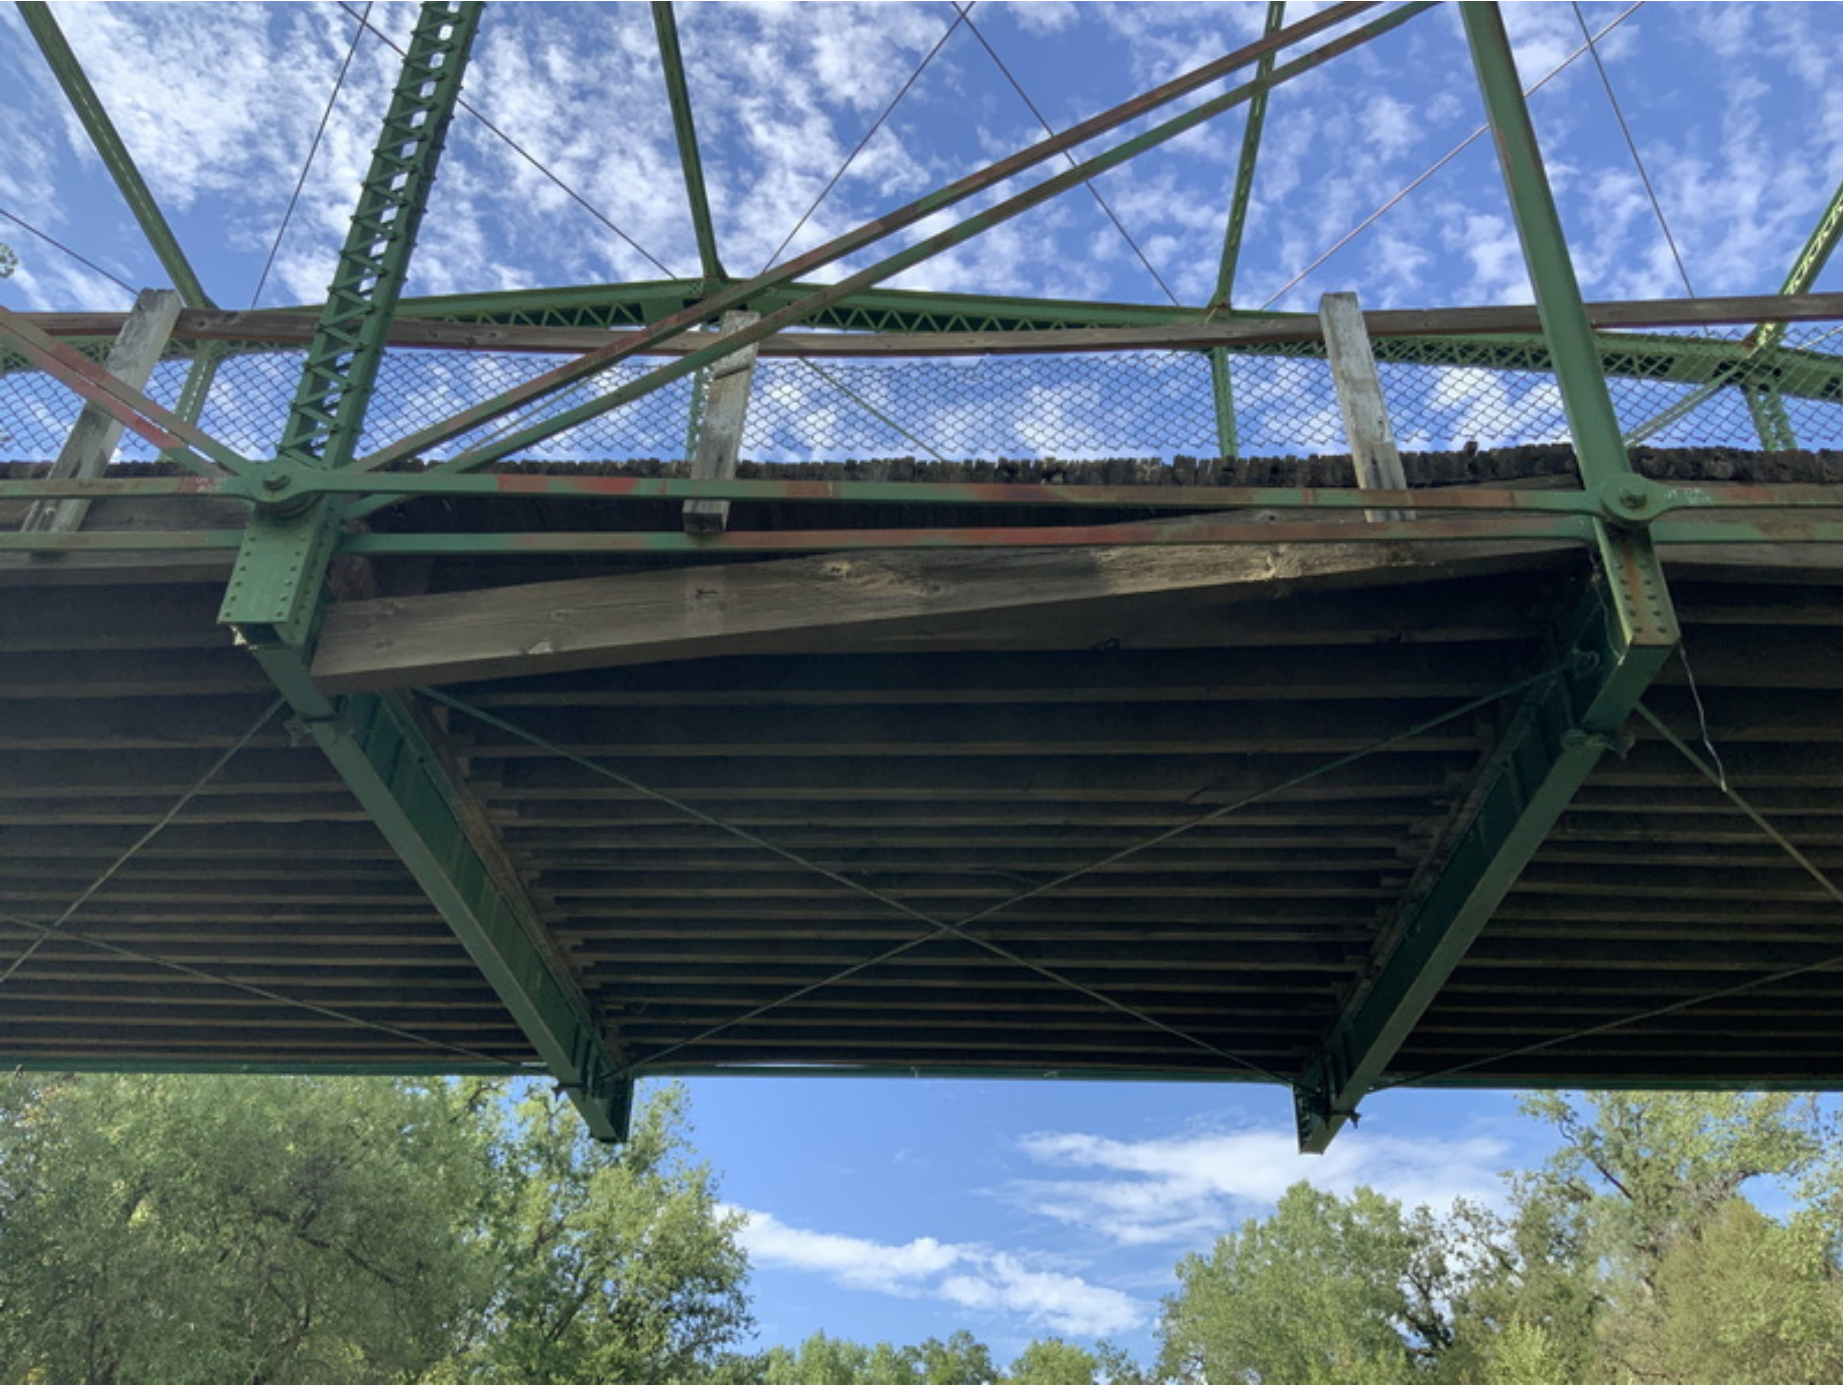
Photo #5
Stringer 17 has completely migrated off of Floor Beam 5
